Real-World Studies: Measuring LEDs in Yuma

CORM Annual Technical Conference

May 2016

Pacific Northwest National Laboratory

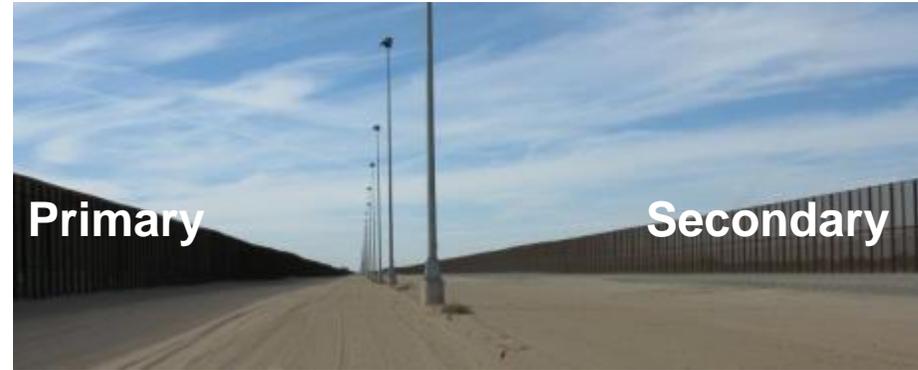
Secondary Fence Line

- 15 x 15 ft. grid
- 9.5 in. above the ground
- 4 ft. and 8 ft. along the fence

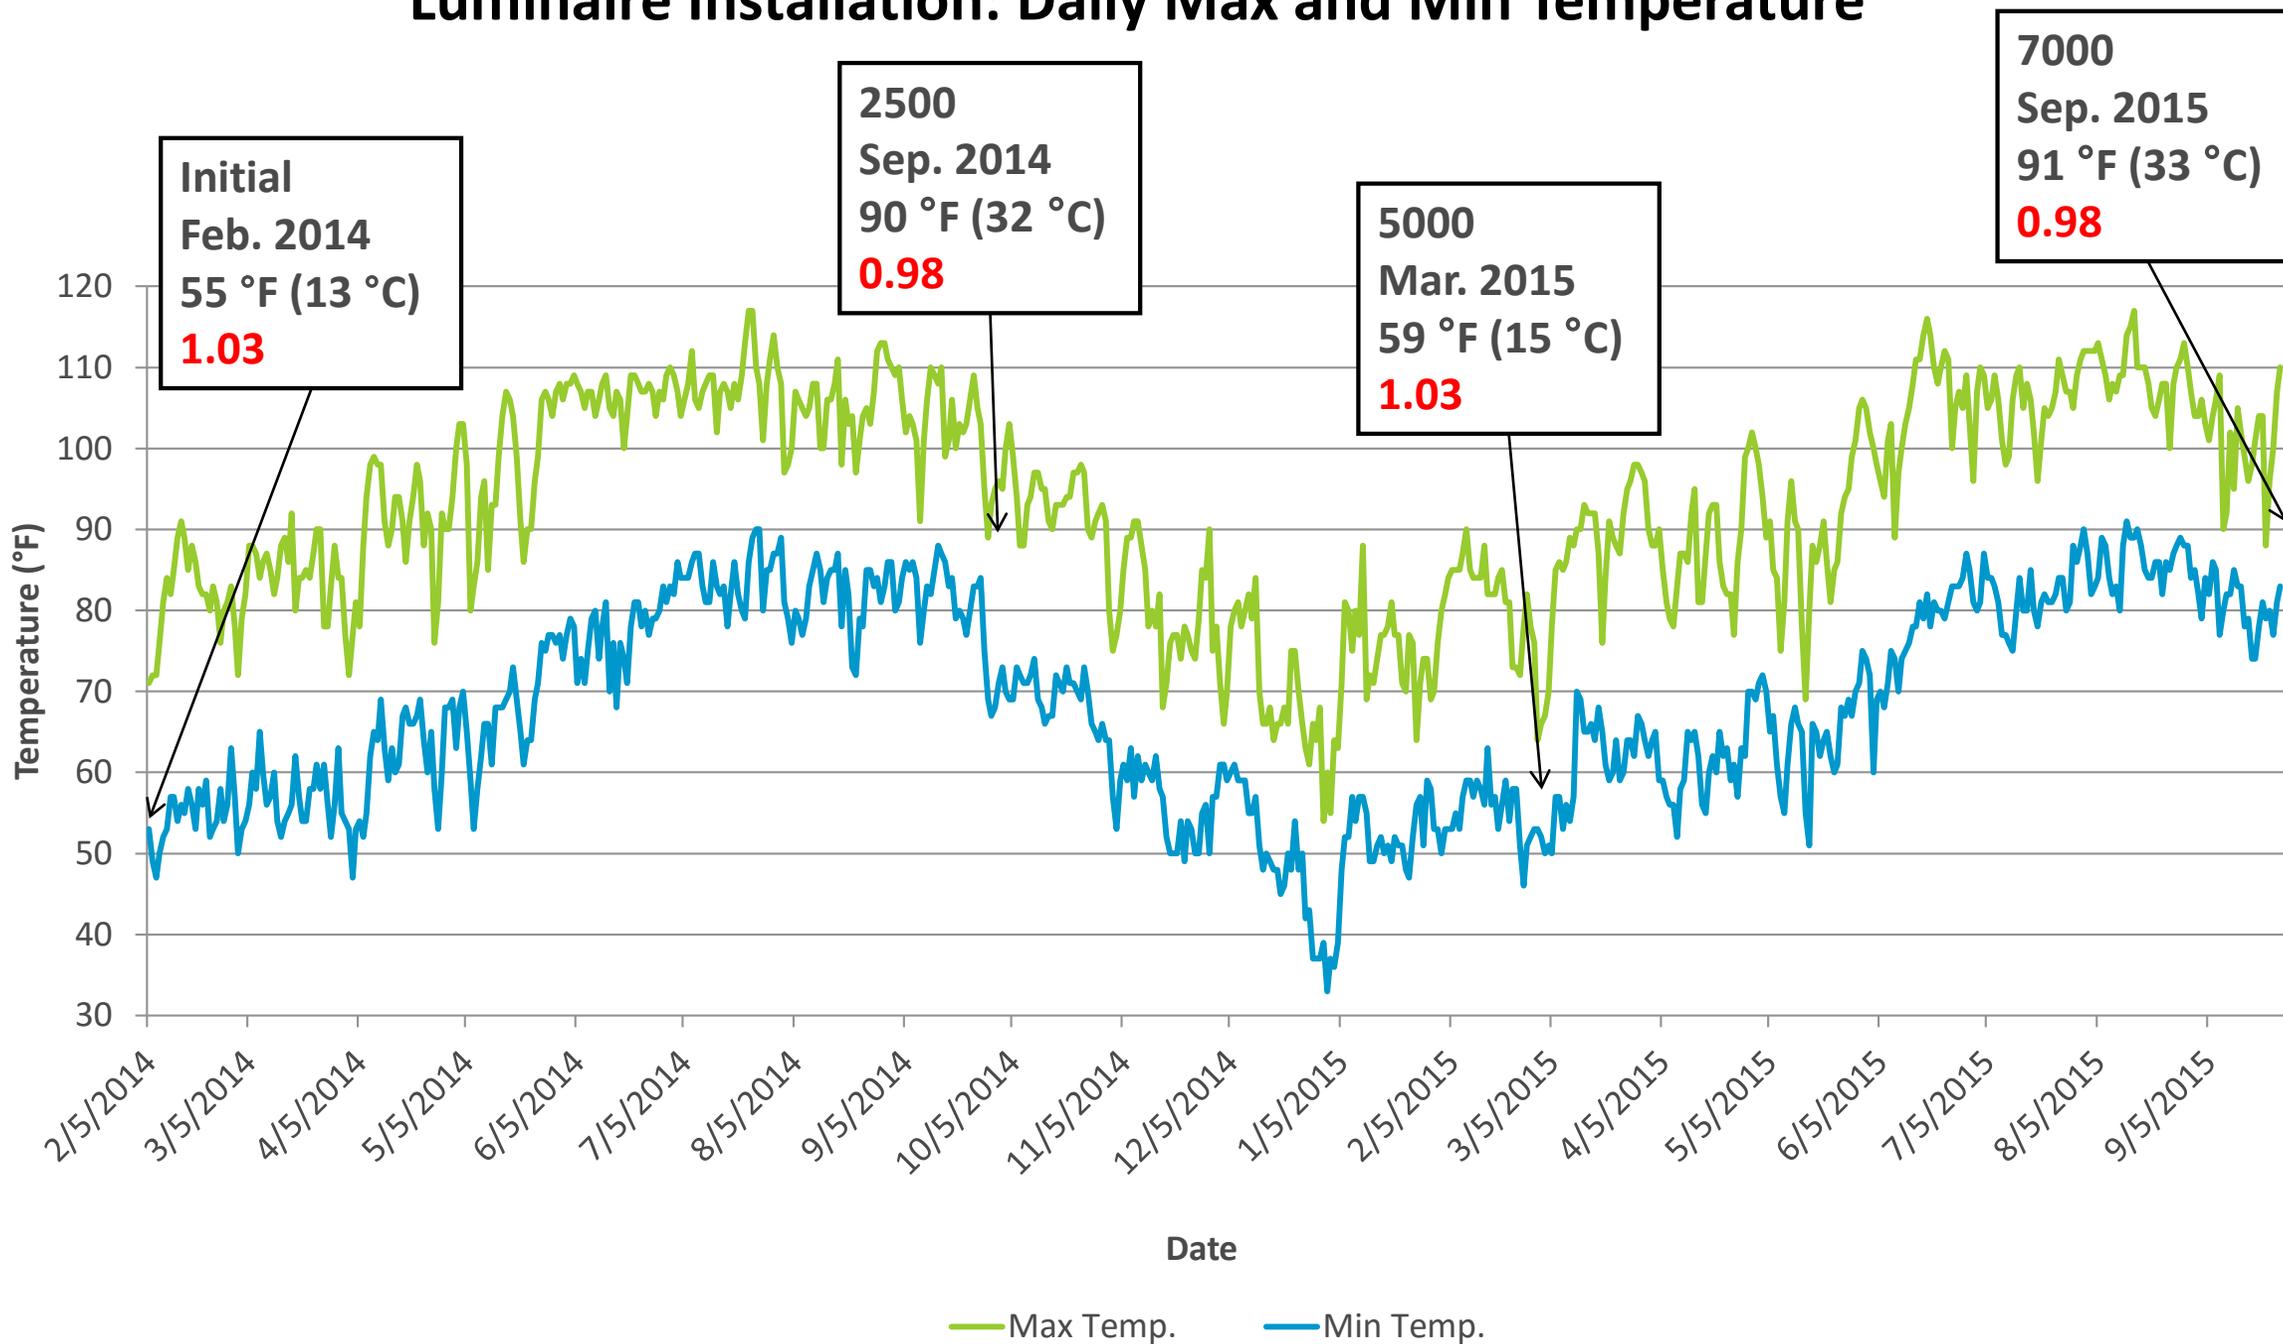
Luminaire Installation: Daily Max and Min Temperature

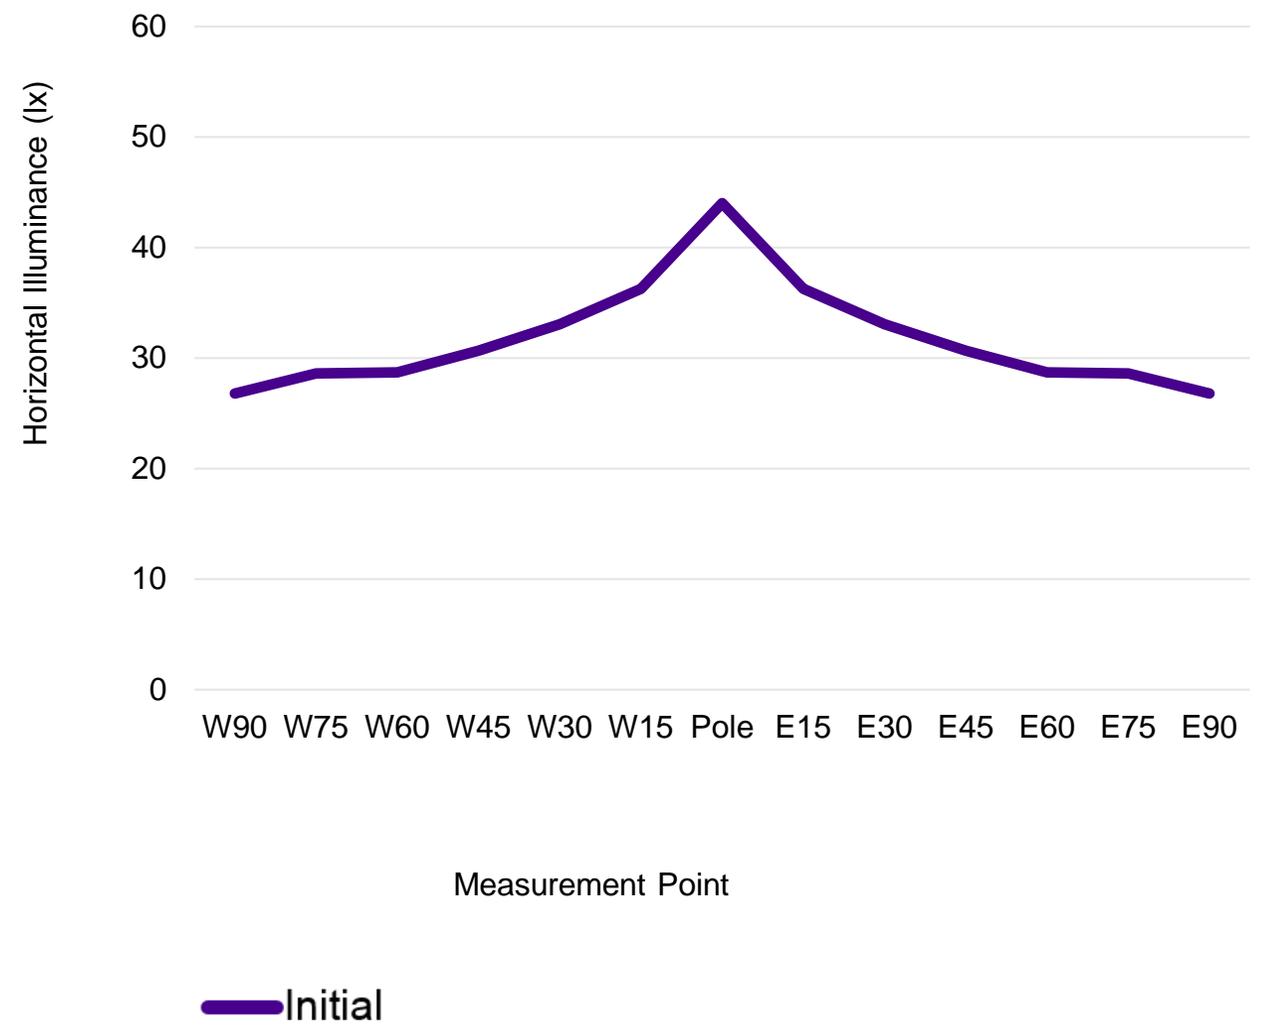
**Initial
Illuminance Measurements
Feb 2014**

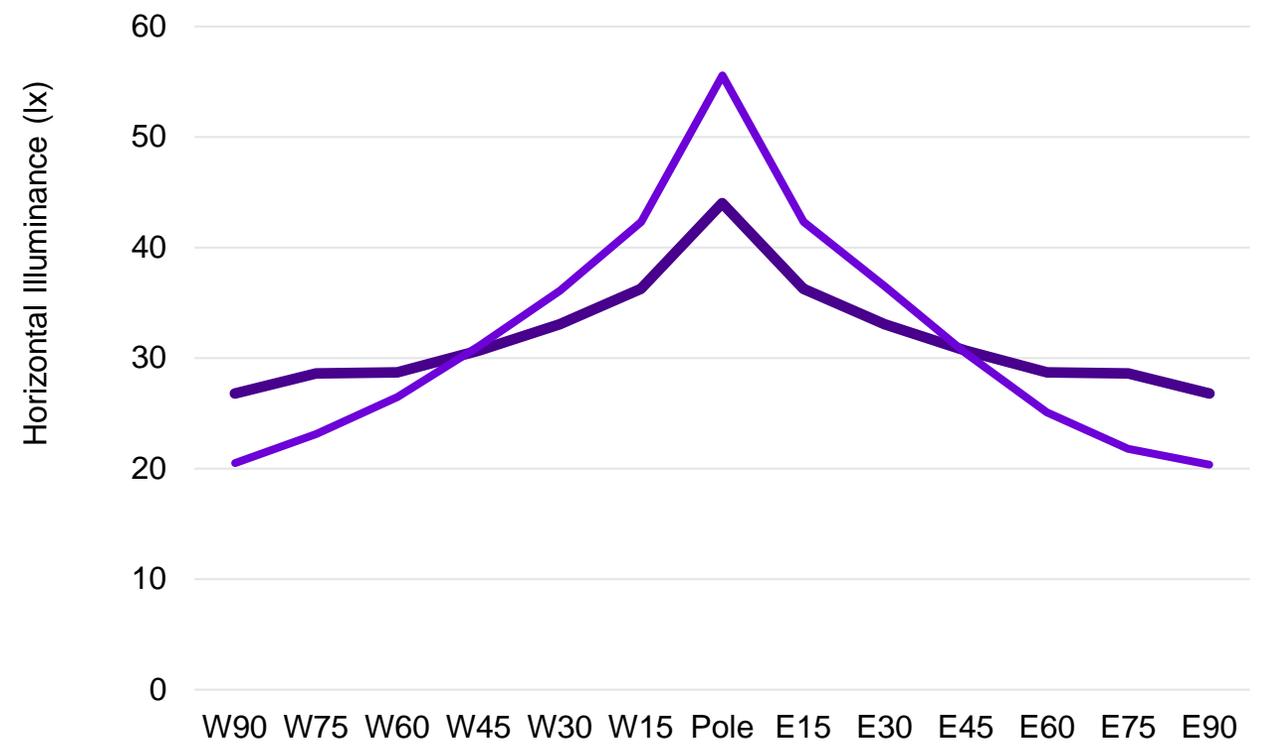
2500 hr
Illuminance Measurements
Sep 2014

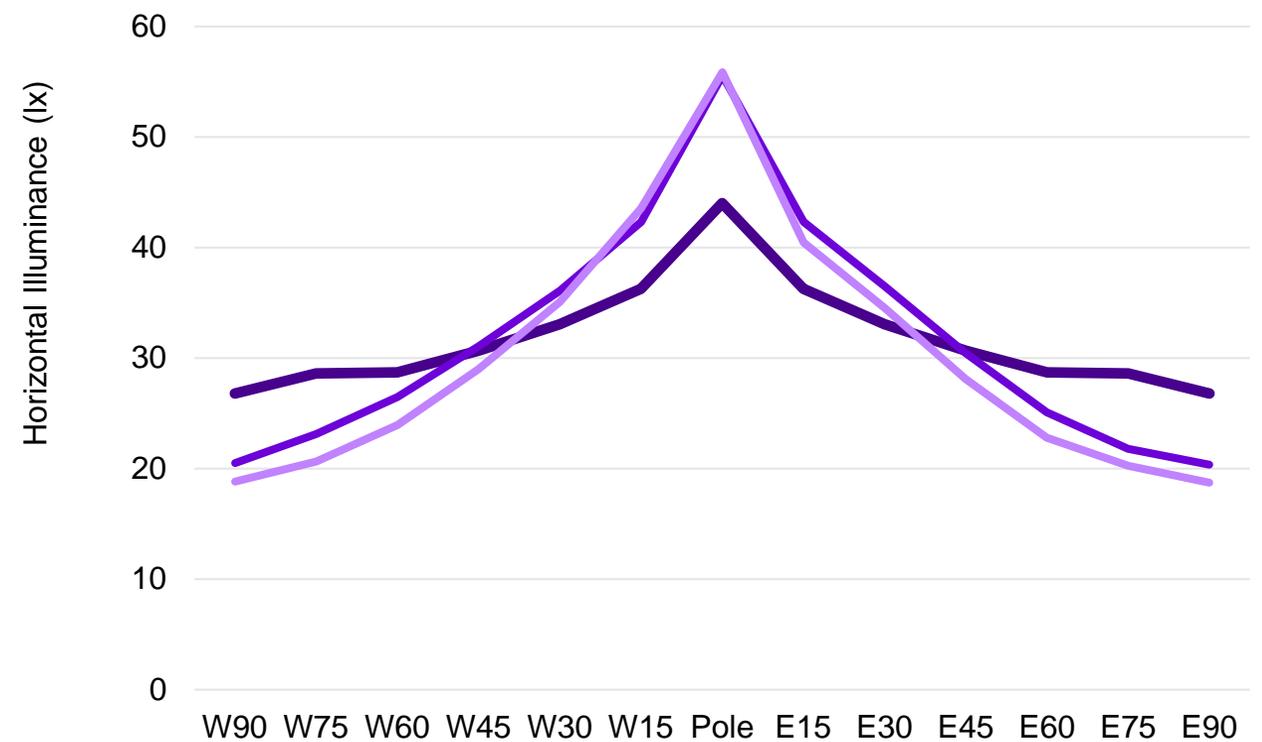
5000 hr
Illuminance Measurements
Mar 2015

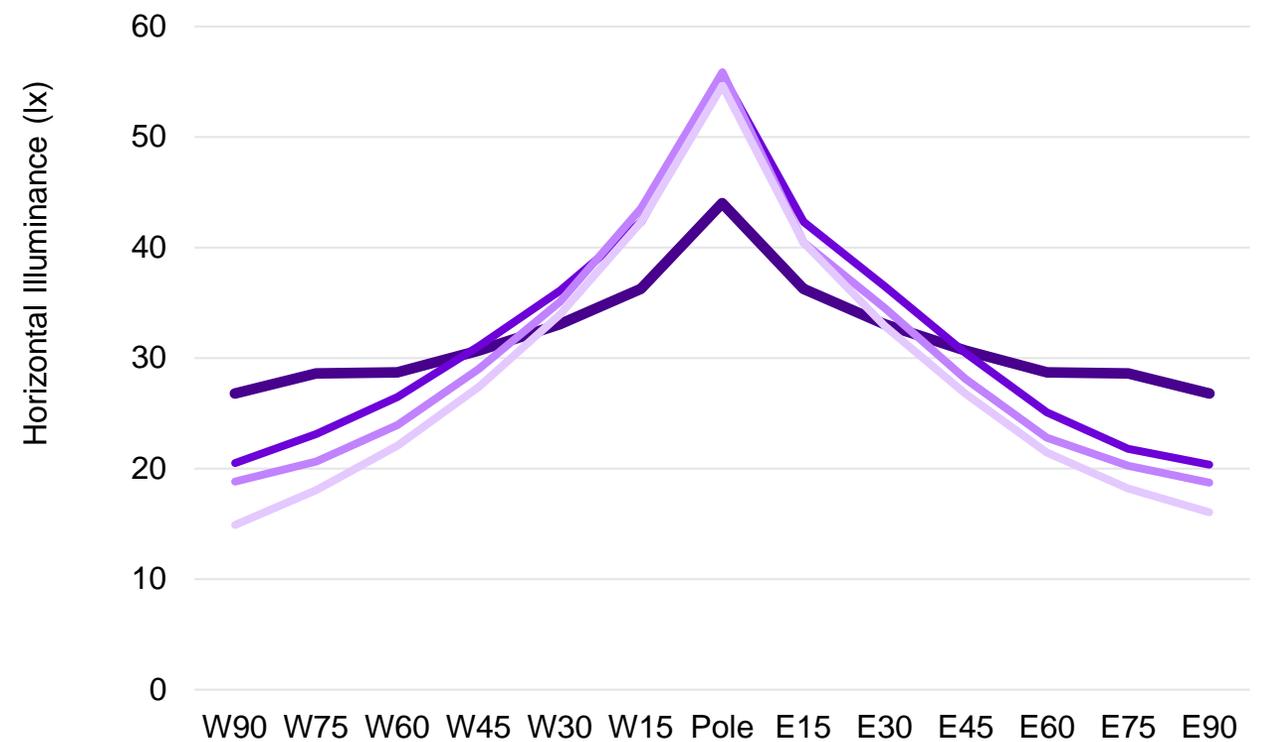
7000 hr
Illuminance Measurements
Sep 2015

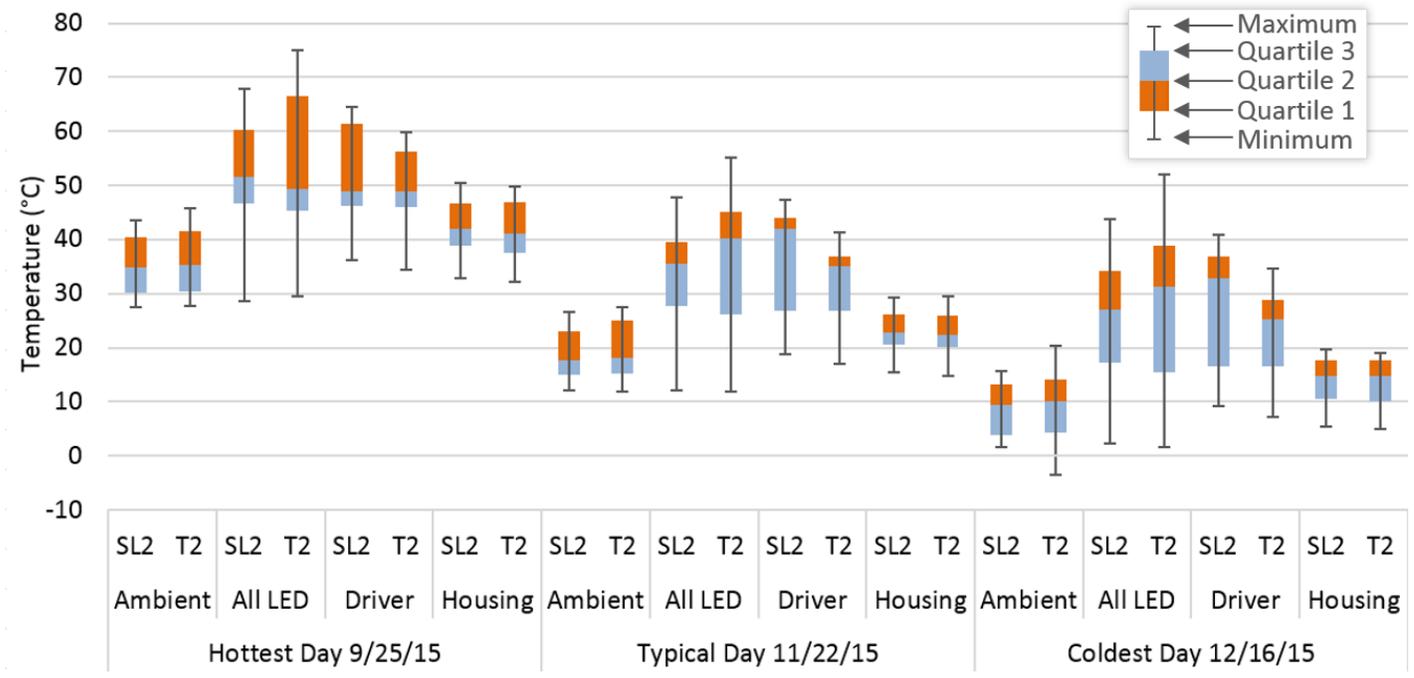
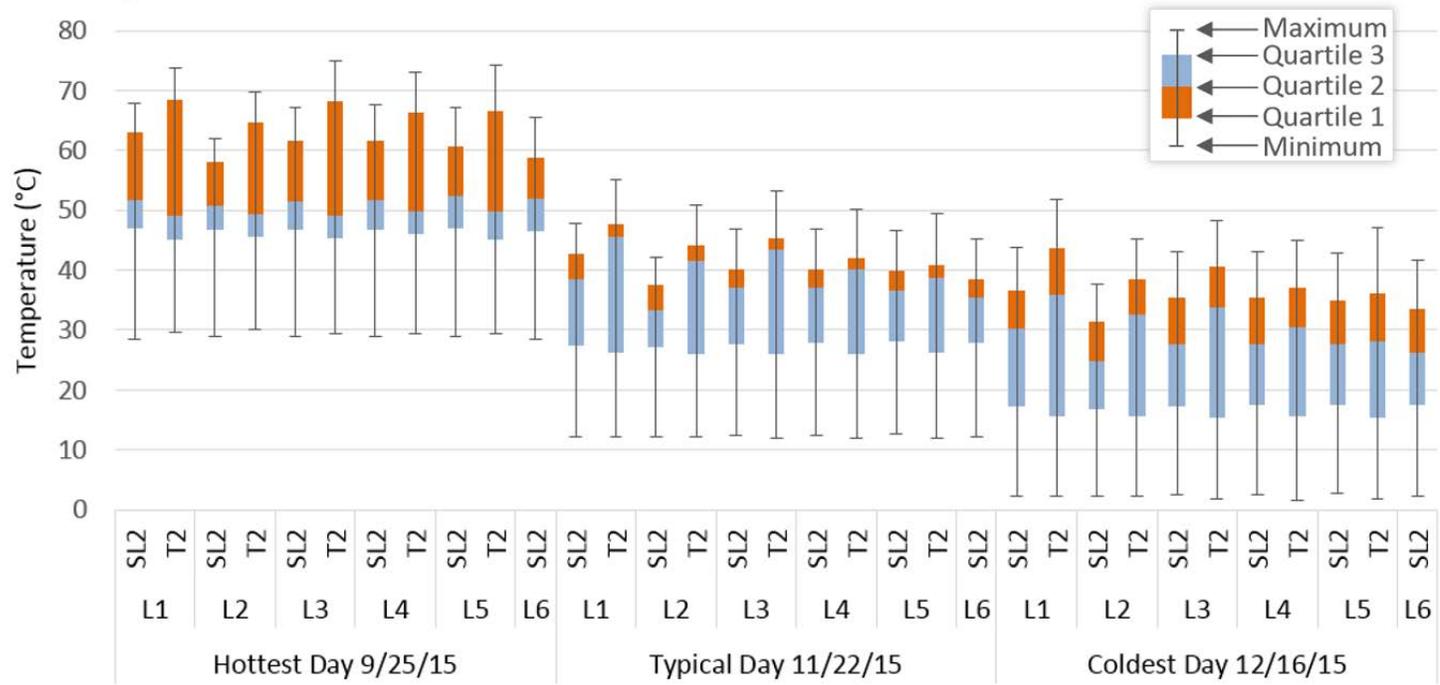
Temperature Measurement Box and Whisker Plots

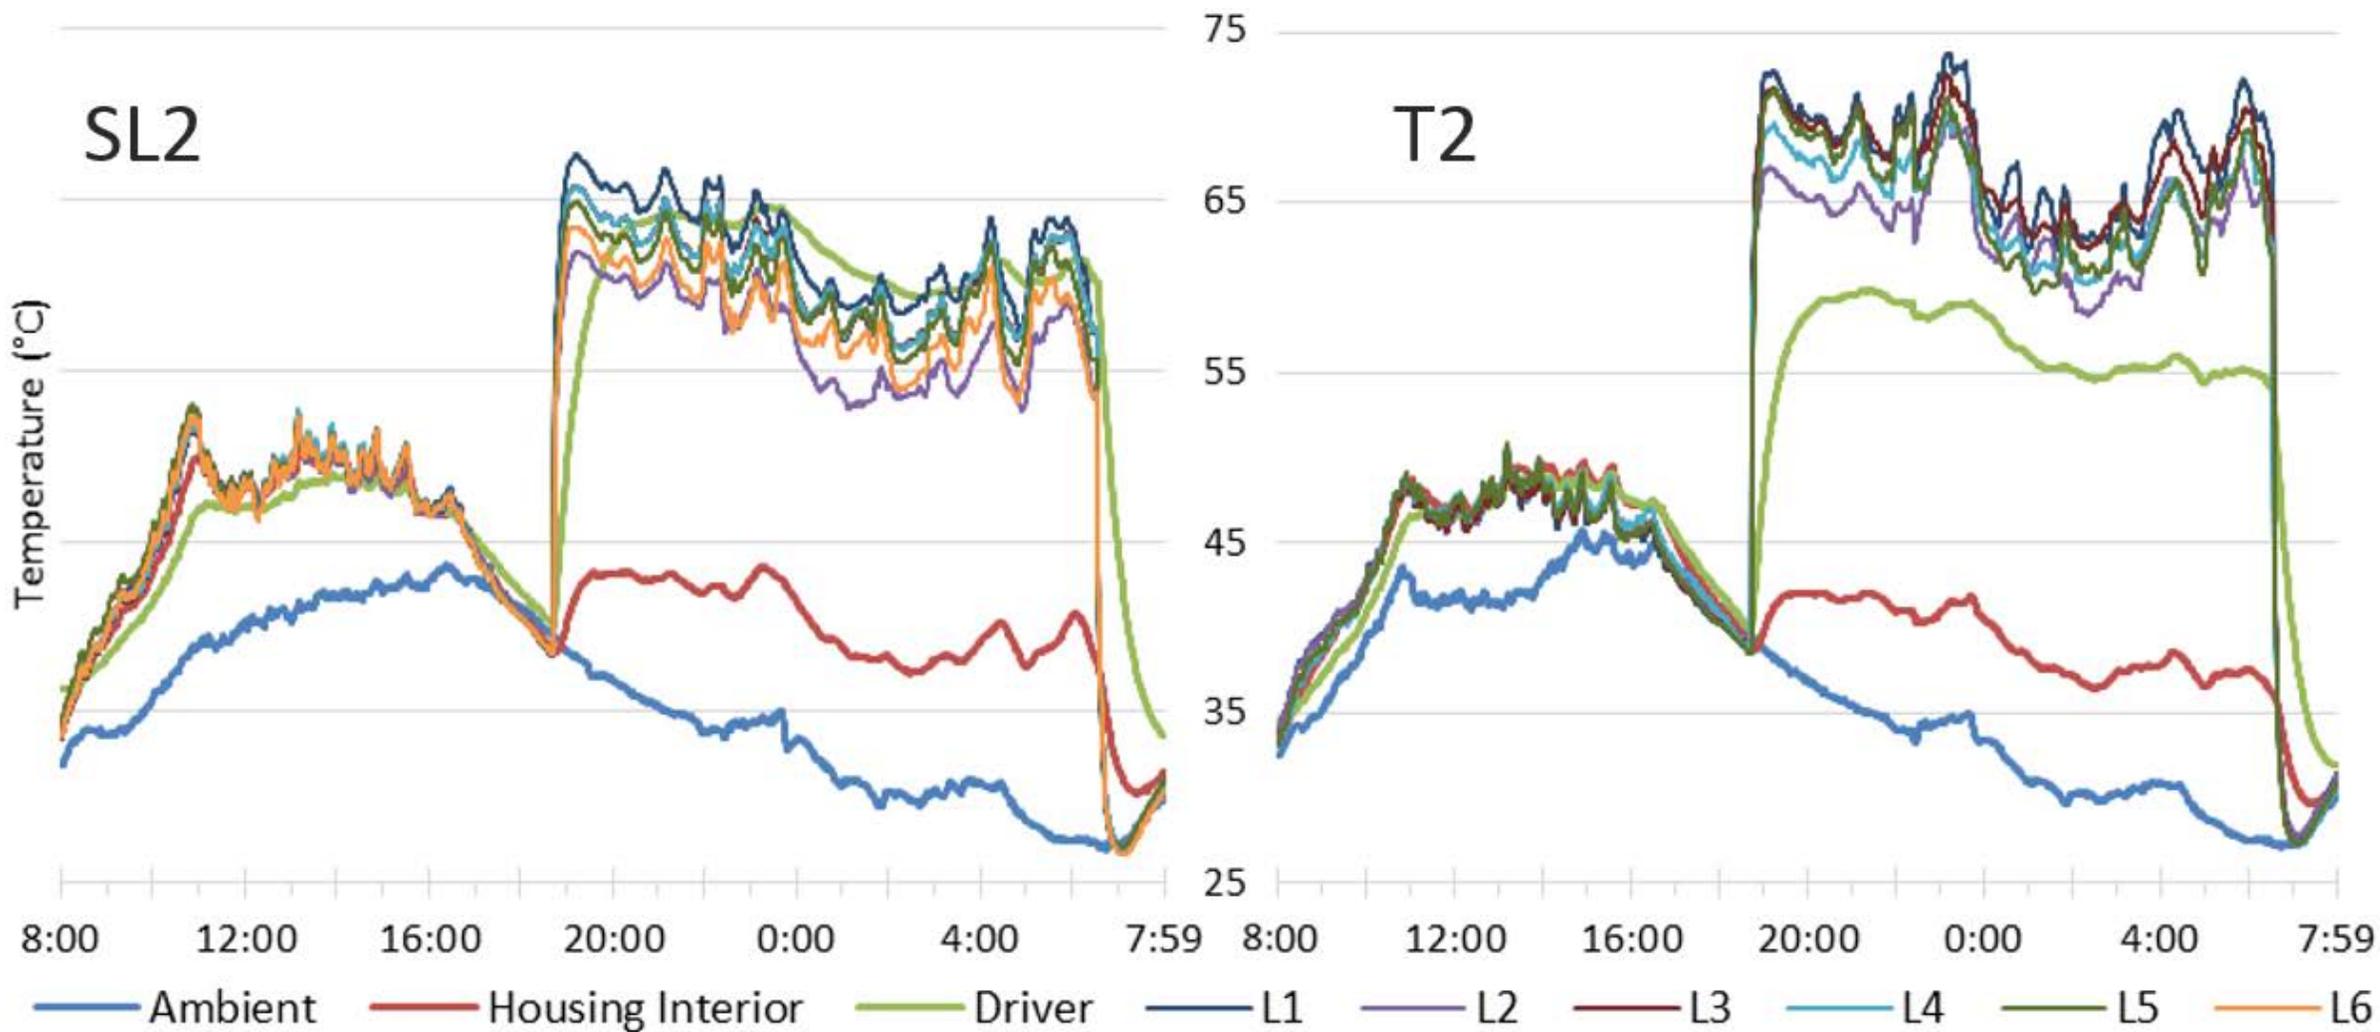
Thermocouple Measurements: September 25 8:00 am to September 26 7:59 am, 2015

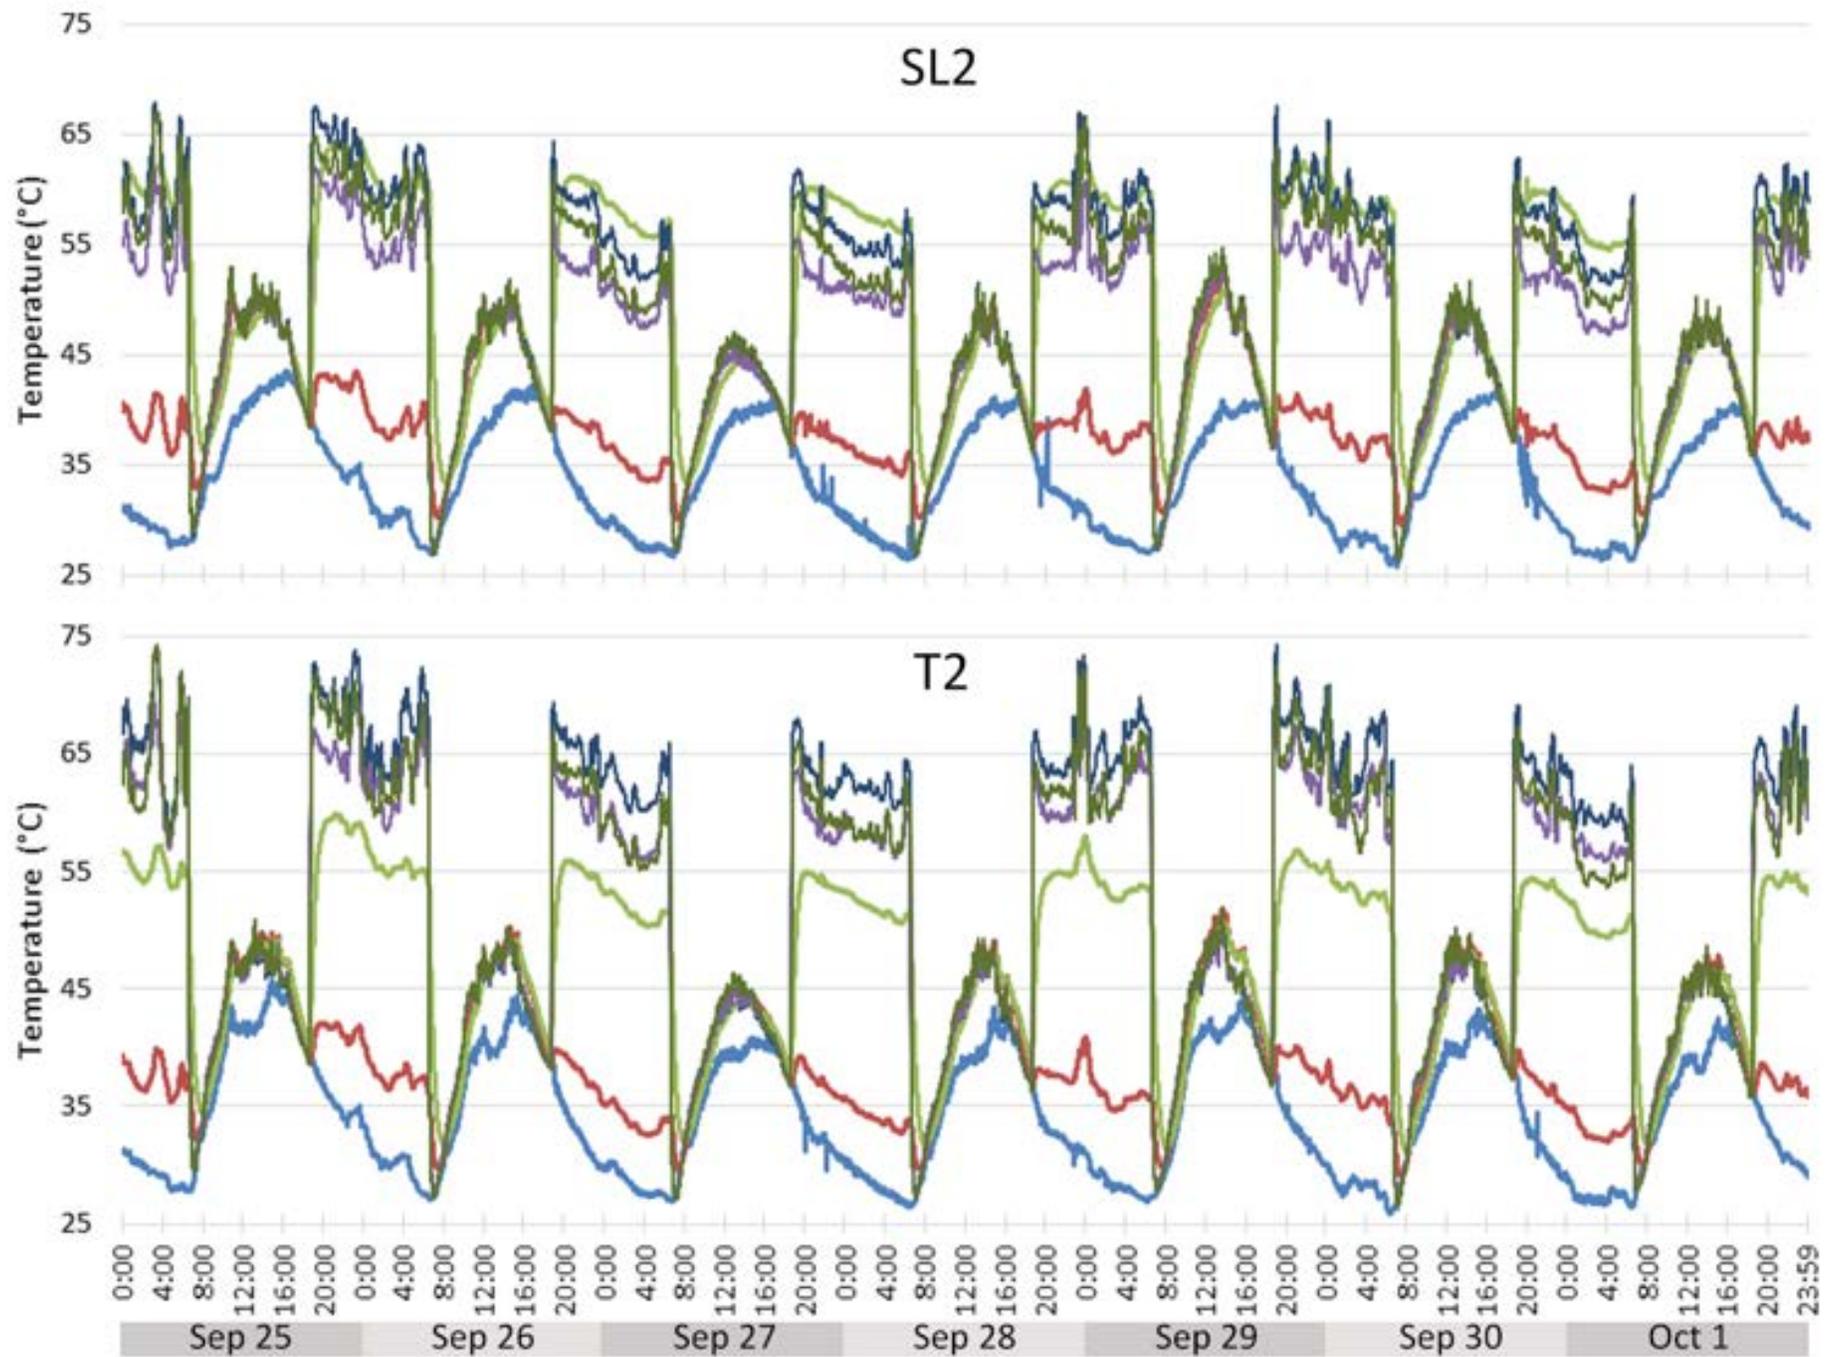
Thermocouple Measurements: September 25 to October 1, 2015

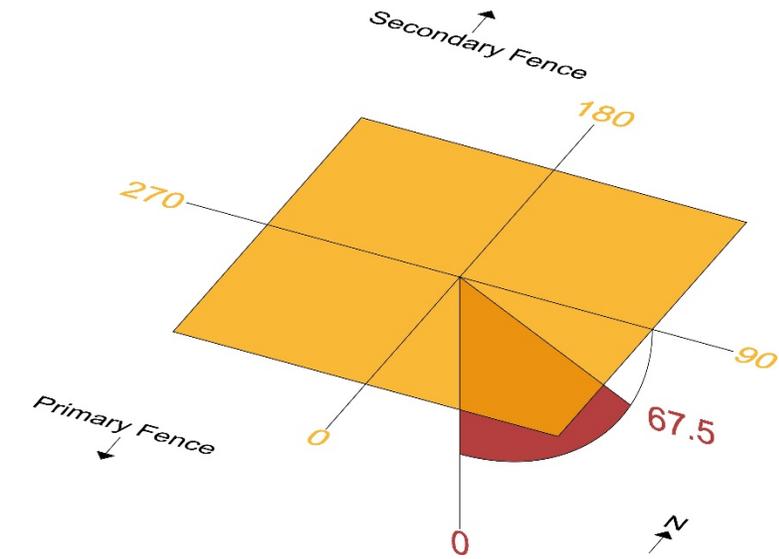
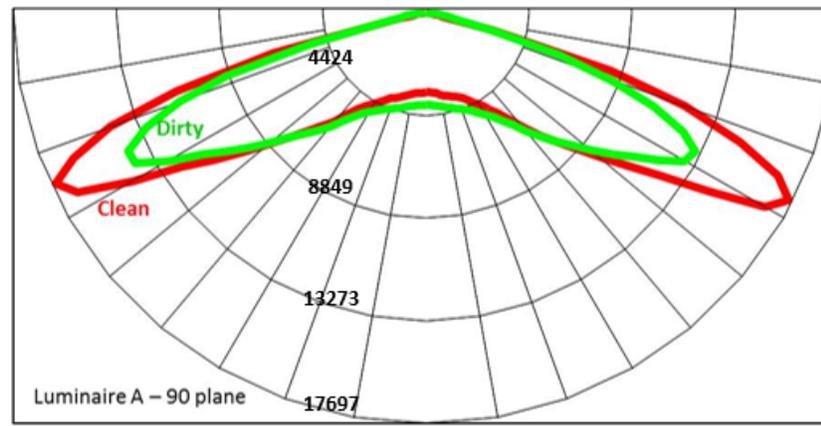
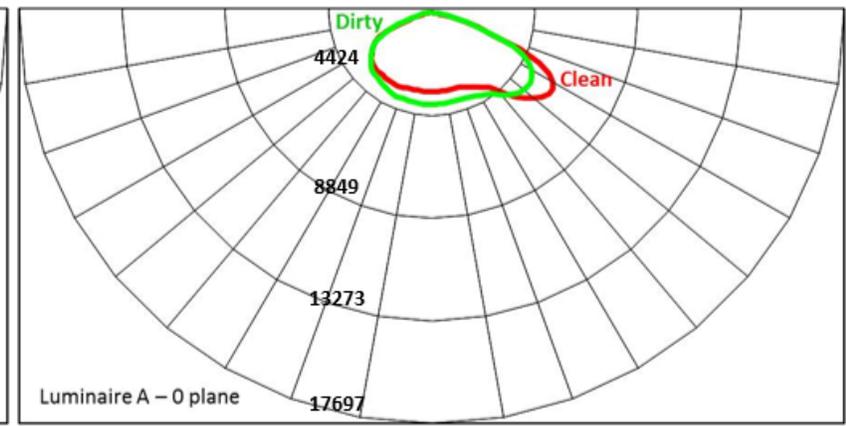
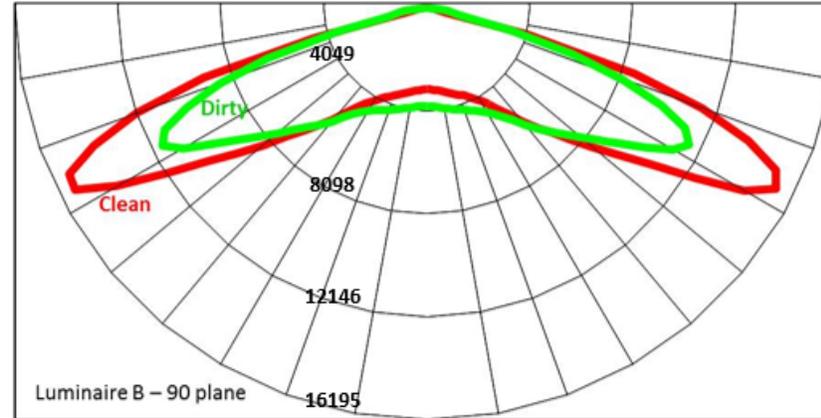
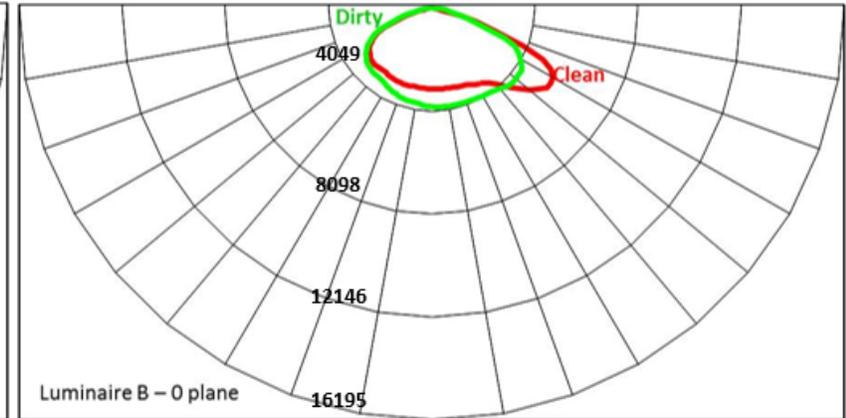
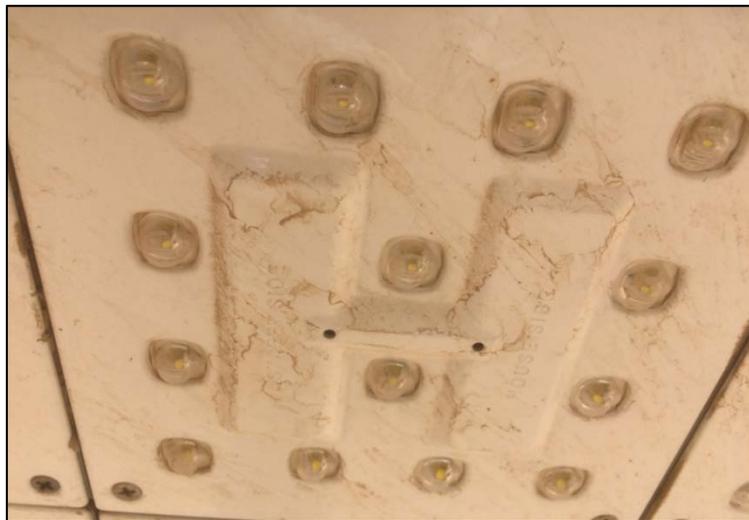
Lab Testing: Clean vs. Dirty

Test	Total Output (lumens)	Peak Intensity at 90° Horizontal Angle (candela) ^b	Peak Intensity at 0° Horizontal Angle (candela) ^c	Intensity at Nadir (candela)
Dirty B Eaton	24,956	11,643	4,226	3,883
Clean B Eaton	27,472	15,471	5,565	3,218
Percent Change Due to Dirt	-9.2%	-24.7%	-24.1%	+20.7%
Dirty A Eaton ^a	27,782	12,970	5,208	3,990
Clean A Eaton ^a	29,881	17,558	6,138	3,436
Percent Change Due to Dirt	-7.0%	-26.1%	-15.2%	+16.1%
